# NAFLIC

TECHNICAL BULLETIN — JUNE 2008

## 344. Mondial Top Scan

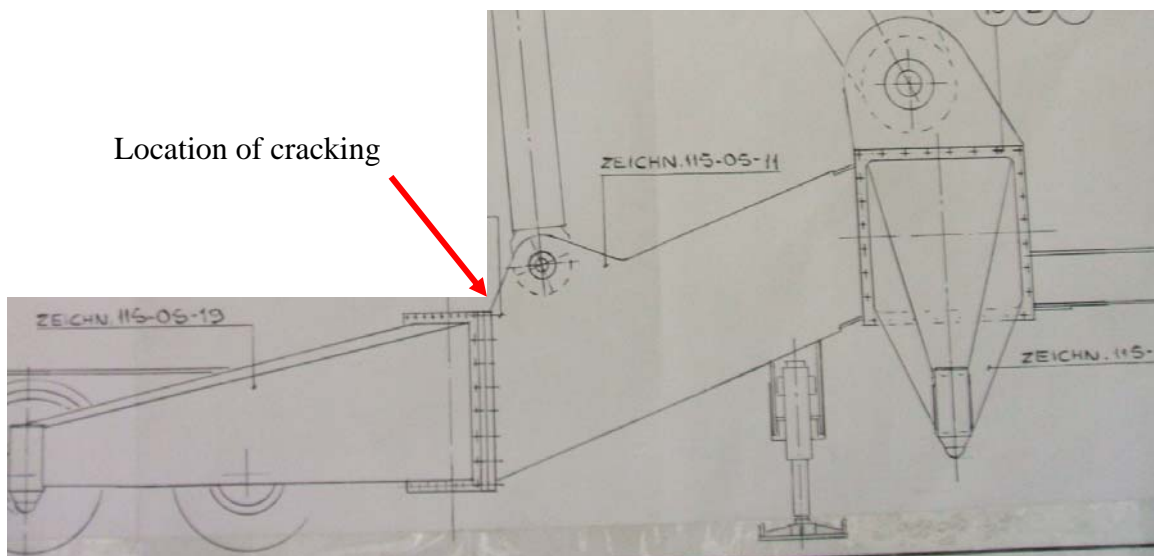
We have been informed by Leisure Technical Consultants Ltd. of defects on the Mondial Top Scan or Top Buzz device. The cracking is located in the outrigger – chassis weldments as shown below.

1. Side elevation drawing showing the location of cracking.  
(Taken from the manufacturers drawing).

A repair procedure must be obtained from Mondial prior to any repairs being carried out.

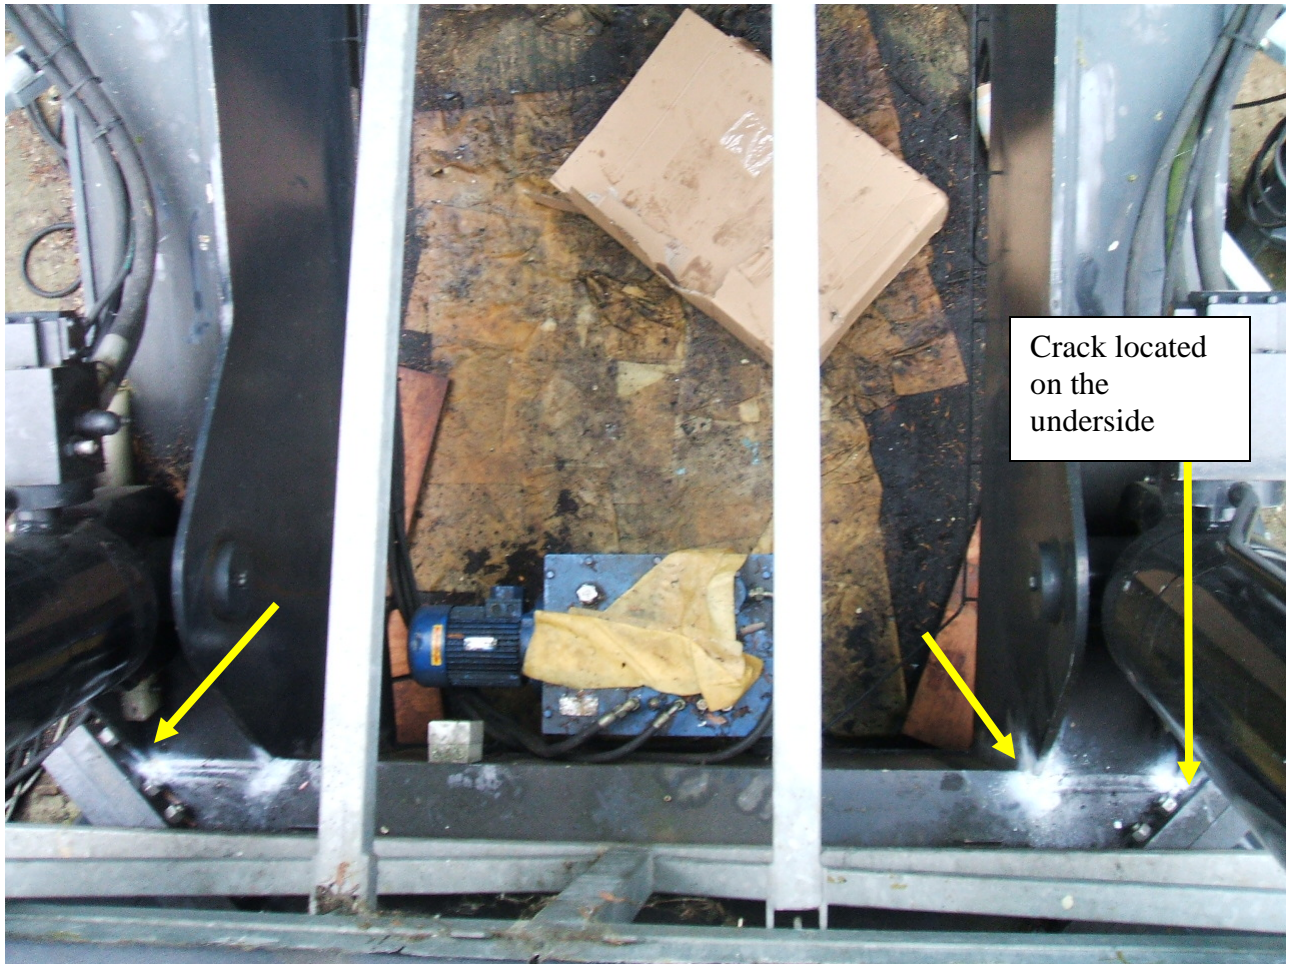
Figure 2 shows the location as viewed from above,

2. Location of cracking on the chassis.
