NAFLIC

TECHNICAL BULLETIN — June 2016

409. Zamperla Watermania main drive pinion failure

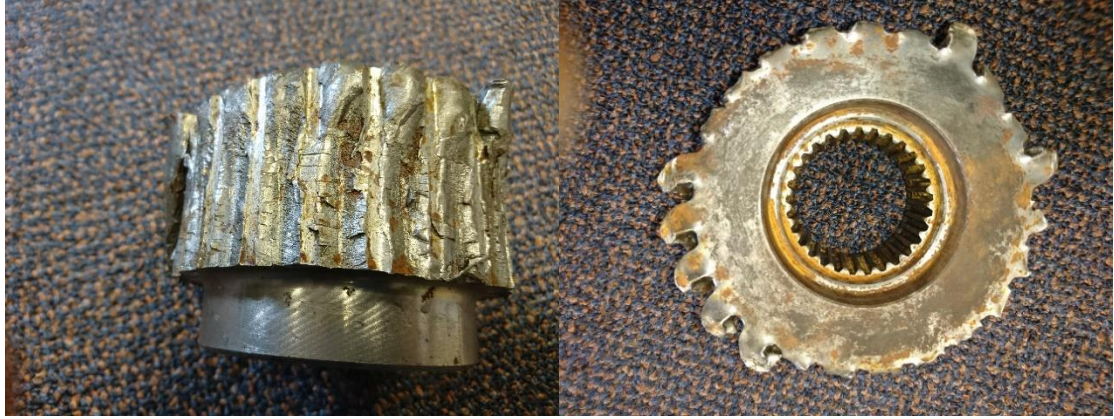
We have received a report from a UK registered inspection body that a main drive pinion on a Zamperla Watermania ride failed within two months of operation. The pinion was subjected to hardness testing and it was found to have not been surface hardened by the manufacturer. A new pinion was obtained from the manufacture but this also failed within two months of operation owing to numerous areas of cracking.

Failed original pinions

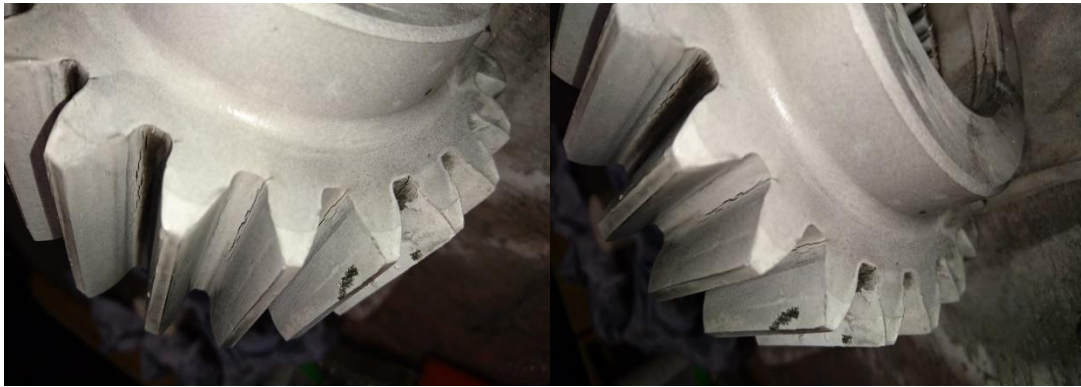
It is not felt that this is a safety critical failure but controllers should bear in mind that these parts are not only found on this type of ride but on others too, where it could also be significant. The original manufacturer's default item was replaced with a hardened piece that also failed. There is also the possibility of sudden stop as a result of this failure.

Failed replacement pinions
