**KMG International BV**

Bulletin No:	FRB24-SB008
Release Date:	August 2 nd , 2017
Effective Date:	August 2 nd , 2017
Supersedes:	none
Completion Date:	See text
Page:	1 of 7

SAFETY ALERT

Ride Mfg:	KMG International BV	Affected Production Dates:	All
Ride Name:	Afterburner / Fireball Afterburner Park model	Affected Serial Numbers:	FRB24 serials 01 – 39 FRB24P serials 01 – 03
Model Number:	FRB24 and FRB24P		
Abstract of Issue:	Inspection of gondola support beam and joint

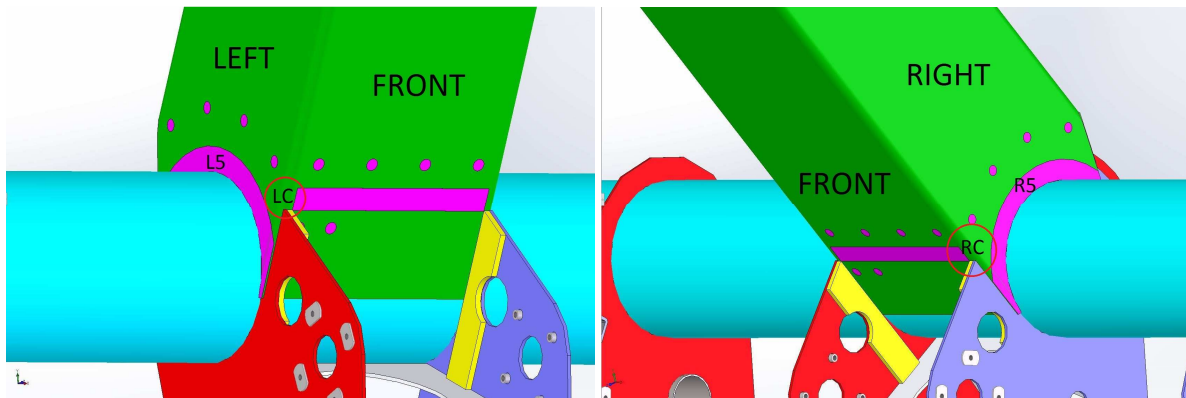
Areas:

- Gain access to all four sides of the gondola support beam and around the joint. The secondary lock solenoid can be left in place.
- Remove all parts and paint in below mentioned areas L5 and R5 on both sides of the beam joint and on both corners LC and RC of the support beam joint:

- Test for cracks using magnetic testing following ISO 17638.

Accepted: Magnetic test results are meeting class 1 criteria as per ISO 23278.

Rejected: Magnetic test results are not meeting class 1 criteria as per ISO 23278.

Do NOT return ride to service.

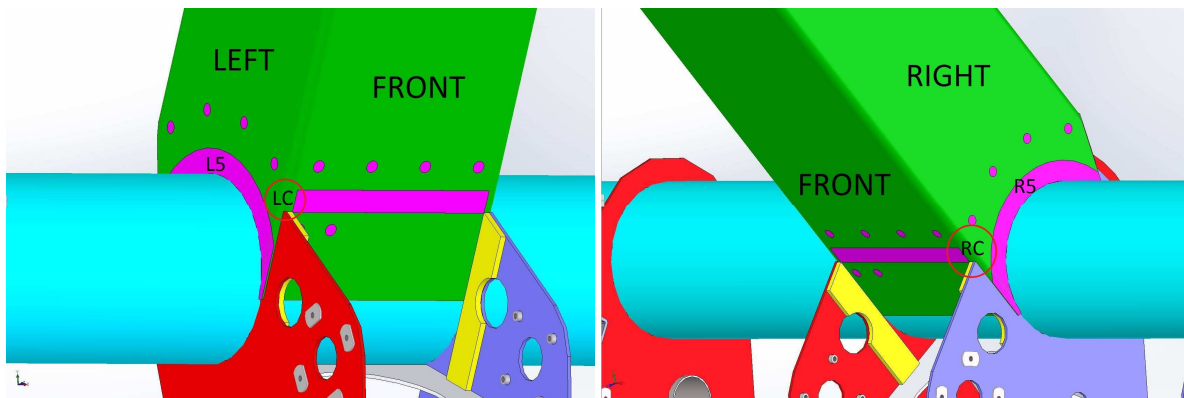
1. Gain access to areas described in below images.
2. Visually inspect areas L5 and R5 and corners LC and RC, looking for cracks. Applicable standard for inspection is ISO 17637 and acceptance criteria following ISO 5817 acceptance class B.

Accepted: Visual test results are meeting class B criteria as per ISO 5817.
 Rejected: Visual test results are not meeting class B criteria as per ISO 5817.
Do NOT return ride to service and consult KMG.
