Bulletin No.: L16-005
Release Date: 3/16/16
Effective Date: Immediately
Supersedes: L13-001
Completion Date: N/A
Pages: 2

SERVICE BULLETIN

Ride Manufacturer: Larson International Inc. Affected Production Dates: All
Ride Name: Giant Loop Affected Serial Nos.: All units

The bolts that secure the train to the undercarriage may exhibit wear and require additional inspection and replacement every two years.

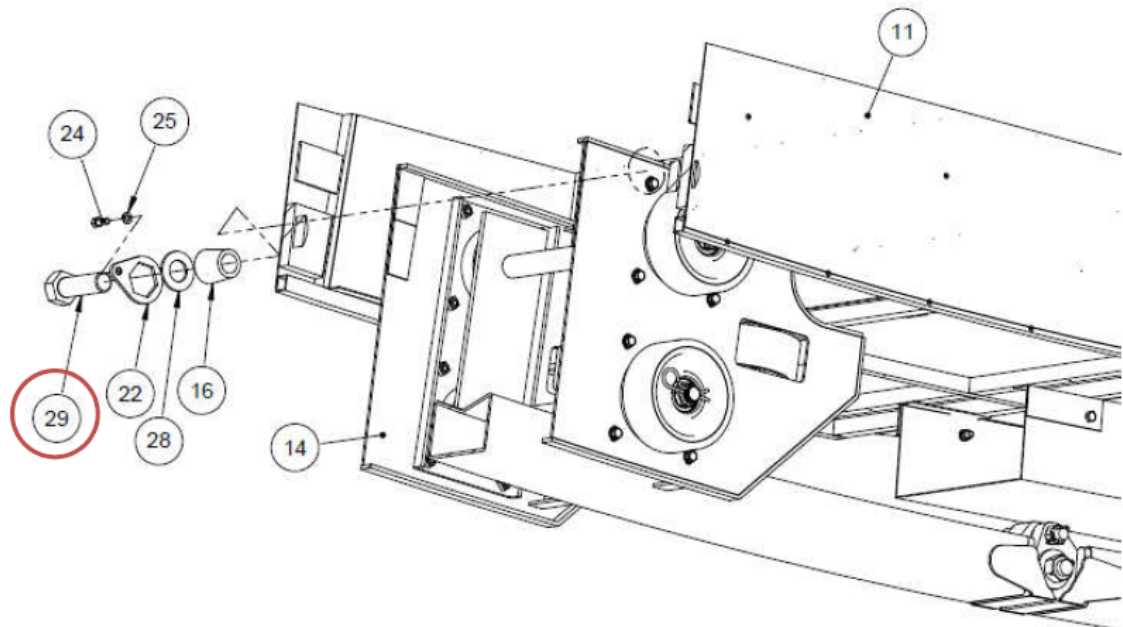
Detail Of Issue:
 (Text/Drawings/Schematics)

Damage to the bolt threads was found when bolts were removed from a Giant Loop that had been in service for three seasons.

1. Monthly Inspection – visual inspection of the train to undercarriage bolt retainers (items 25-27).
2. Six Month Inspection – verify that the train to undercarriage bolts are snug-tight [AISC definition].
3. Annual Inspection - remove rubber bushings and visually inspect all fasteners, tapered rubber bushings and bolt retaining plates.
4. Every Two Years - replace train to undercarriage bolts (item 29 on page 2).

Note: Initial installation of the bolts compress the rubber bushings to within approximately ¼ inch of steel to steel contact. If a rubber bushing is compressed to the point where rubber shears off or there is steel to steel contact, it must be replaced. If the rubber bushings require replacement, apply EP2 lithium grease to the taper prior to installation.
