TECHNICAL BULLETIN — June 2016

413. Nottingham UK Miami - corrosion to over the shoulder passenger restraints

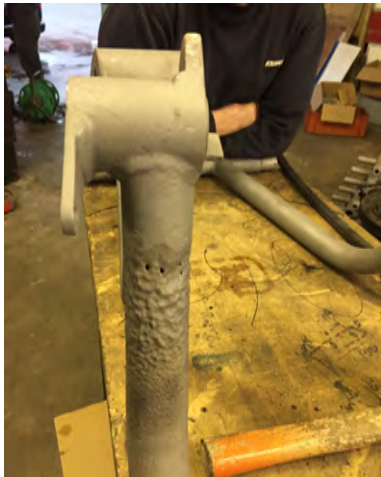
- 1) As part of the annual inspection, surface corrosion was noted at the hinge / tube connection point of the overhead restraint bars, the device has 16x single overhead units, the outer polyurethane (padding) covering was removed from 2x safety bars as a percentage strip down, the results can be seen from the 2x attached pictures, there is no documented history of this level of stripdown being carried out on this device- as such we shall assume this is a progressive corrosion over the life of the device – the padding once removed was found to have degraded and as such water and moisture was trapped – sponge like against the steel work.

- 1) miami; overhead lap bar stripped down – padding removed.

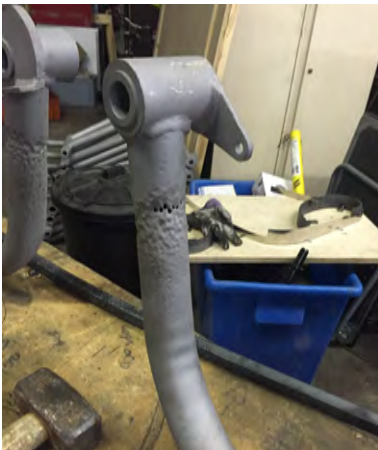
- 2) The remaining units were stripped down and 14 out of 16 were found to be in varying stages of extreme corrosion.
- 3) The manufacture has supplied 16x new units of which the steel work is galvanised.

- 4) Contact with the manufacturer of the polyurethane covering has confirmed the moulding is weather proof until the outer membrane / finishing is damaged or broken, the other point of entry for water is the sealing between the tube and top of the covering.

- 2) showing corrosion of tube steel section.
- 3) Showing new safety restraint bars fitted.
