TECHNICAL BULLETIN — February 2015

391. Pinion and slewing ring inspection

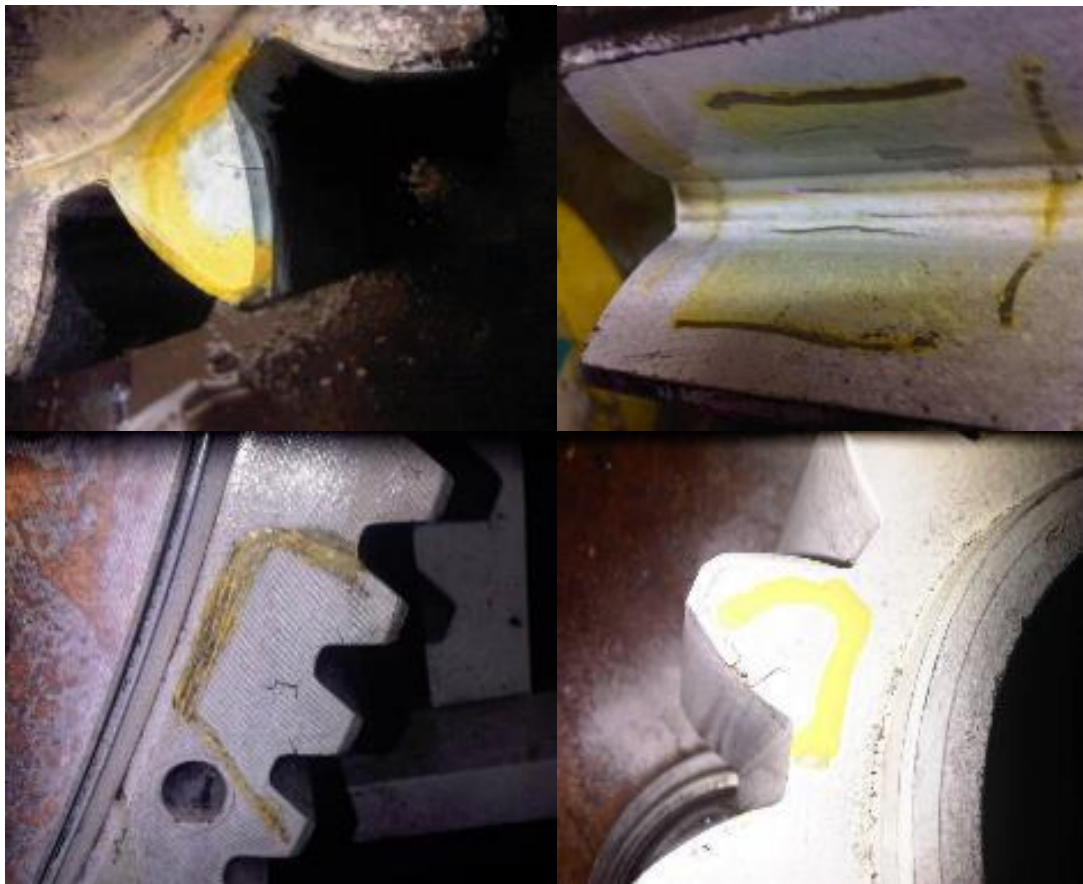
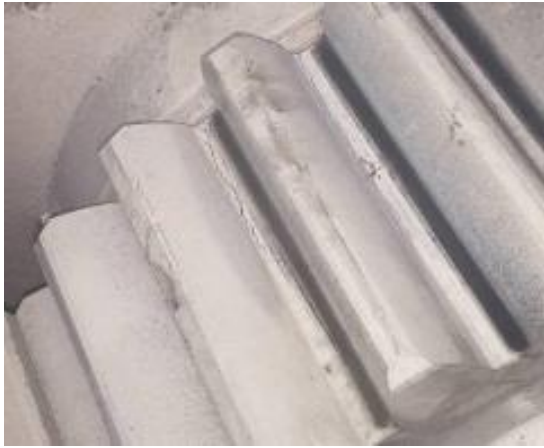
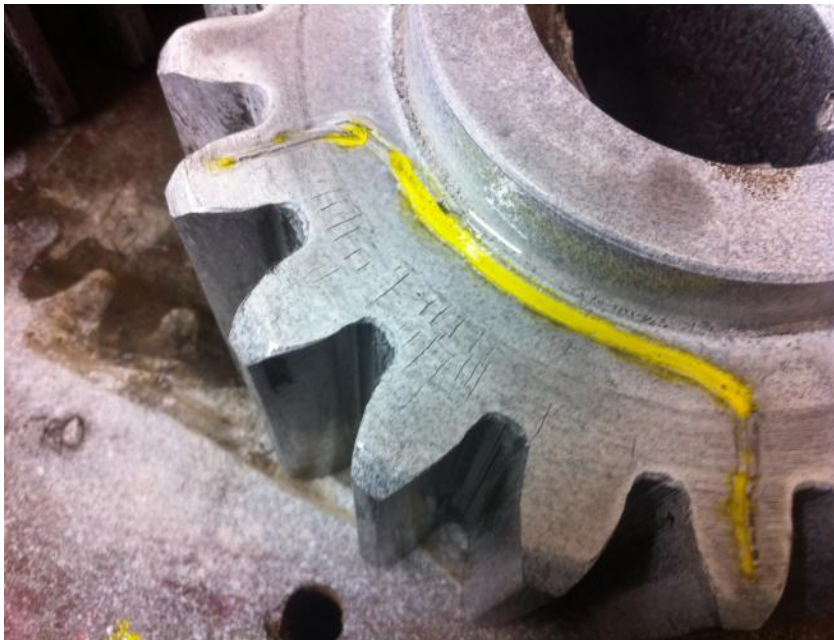
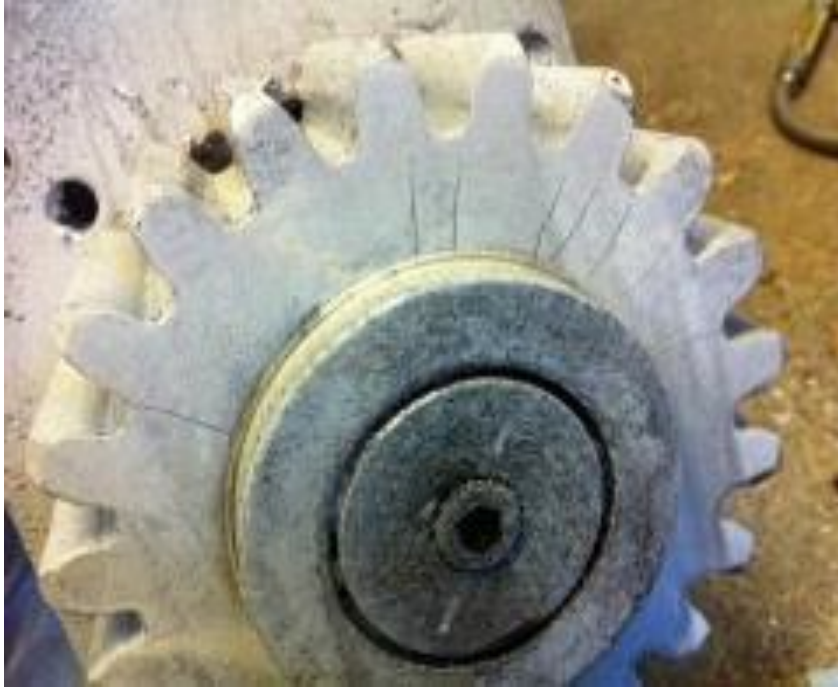
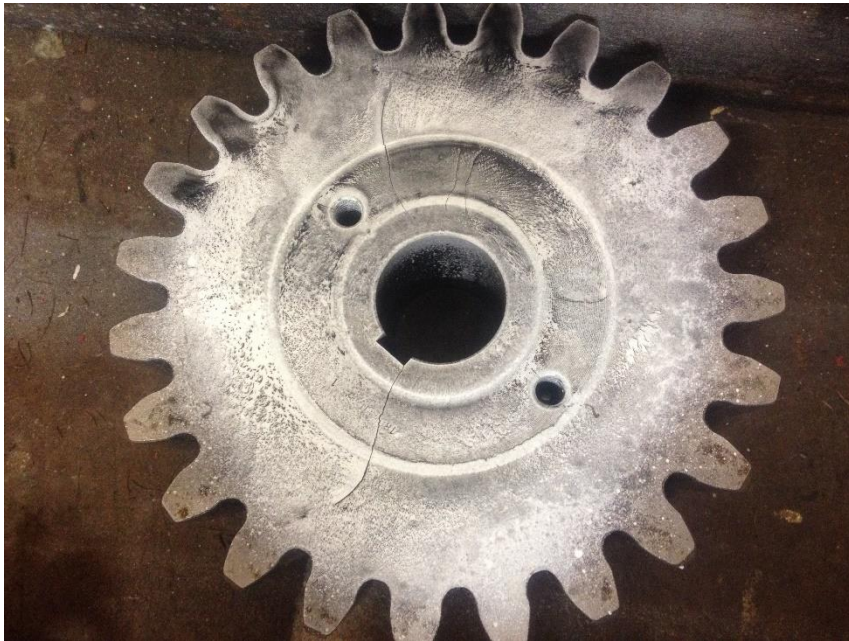
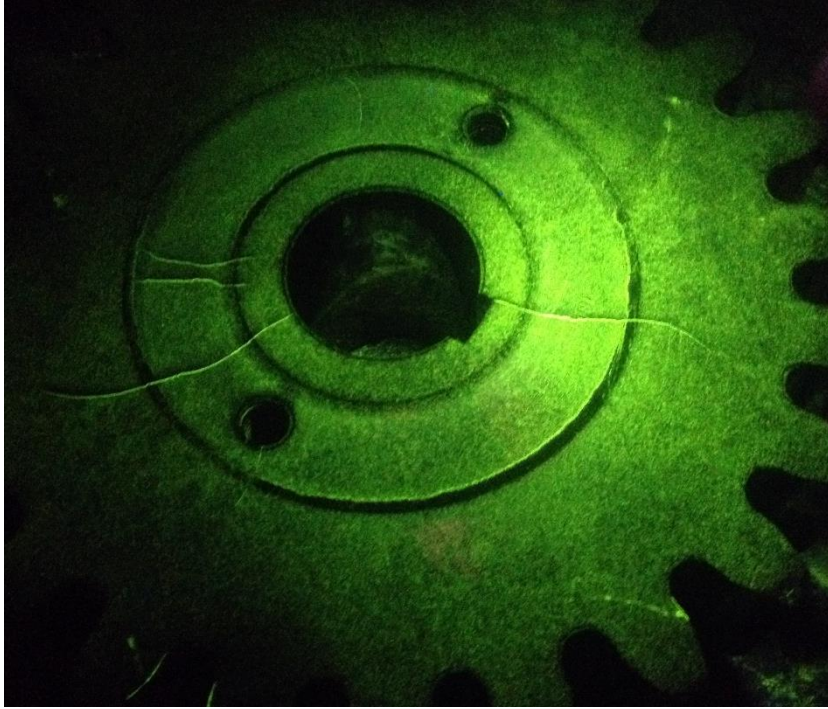
A UK registered inspection body has kindly shared a sample of some of their photographs from failed pinions and slew-rings which were discovered during their annual inspections. The inspection body has informed NAFLIC that these components were from a wide range of rides and not just the high speed, high force devices. Their findings re-enforce the need to always inspect these types of components in an annual inspection. Drive pinions may not primarily be considered to be safety critical components. However under certain circumstances, for example if a tooth was to break off and become jammed between the pinion and slewing ring, it could lead to rapid deceleration.
