SERVICE BULLETIN

Ride Manufacturer: CHANCE RIDES, INC.	Affected Production Dates: All
Ride Name: YO YO	Affected Serial Nos.: All Units
Model No.: 376

Abstract of Issue:
 Sweep Lift Cylinder Bearing Inspection

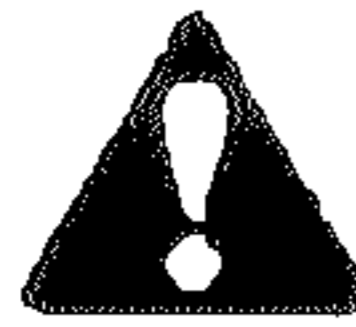
Inspection Procedure - Sweep Lift Cylinder Bearing Assembly
(refer to the illustration on page 4 of this bulletin)

1. Remove the eight (8) capscrews which secure the cover to the bearing housing. Remove the cover.
2. Clean the grease off of the cylinder rod and lock nuts to gain access to these parts for inspection.
3. Measure the cylinder rod protruding past the upper lock nut. There must be 1/8" to 1/4" of the cylinder rod protruding past the upper lock nut (approximately 3 full threads). If this measurement is correct, proceed to the next step.
4. With the assistance of two helpers to MANUALLY rotate the sweeps as instructed in the Operation Manual. Observe the components from above while the ride is turning.

- The inner race of the upper bearing must remain stationary in relation to the cylinder rod.
- The spacer must remain stationary in relation to the cylinder rod
- Listen for any unusual noises from the bearing. Look for any unusual movement of any component.

5. Stop turning the ride. Use a 0.002" feeler gauge to look for clearance between the spacer and the inner race of the upper bearing as shown. Check this around the entire circumference of the spacer. There should be zero clearance at all locations.
