WHITE WATER®

Bulletin No: SAF-STC20-18-1

SAFETY ALERT

This alert is being issued to notify customers with Hopkins and WhiteWater Shoot the Chute rides of the potential for cracks to develop in the vehicle wheel casters.

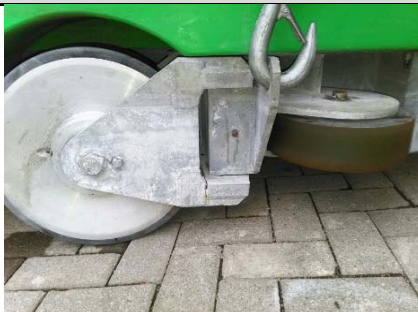
Cracked Caster on Vehicle

1. Immediate and ongoing inspection of all wheel casters is required per Maintenance Manual Addendum 424431-*Shoot the Chute Caster Inspection Addendum*. Weekly and daily maintenance items are to be performed immediately. Quarterly and annual maintenance items to be performed with the next scheduled maintenance interval from receipt of this notice.
2. In the event that any wheel caster exhibits cracks or fails in any way, remove the vehicle from service and contact WhiteWater After Sales for assistance.
3. In the event of having to replace casters, an inspection by certified WhiteWater personnel may be required.

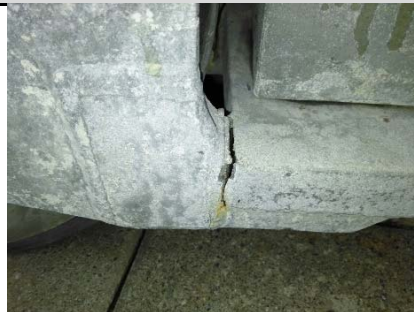
Large Crack in Caster

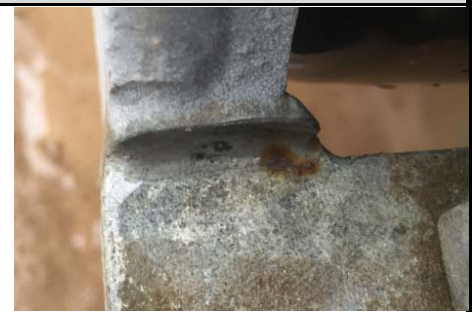
Crack Developing in Caster
